ANNUAL REPORT FOR 2015

Middle Fork Creek Site I Mitigation Site
Madison County
TIP No. R-2518A
COE Action ID: SAW-2007-2197-357/300
DWR #: 20071134

Prepared By:
Natural Environment Section & Roadside Environmental Unit
North Carolina Department of Transportation
November 2015

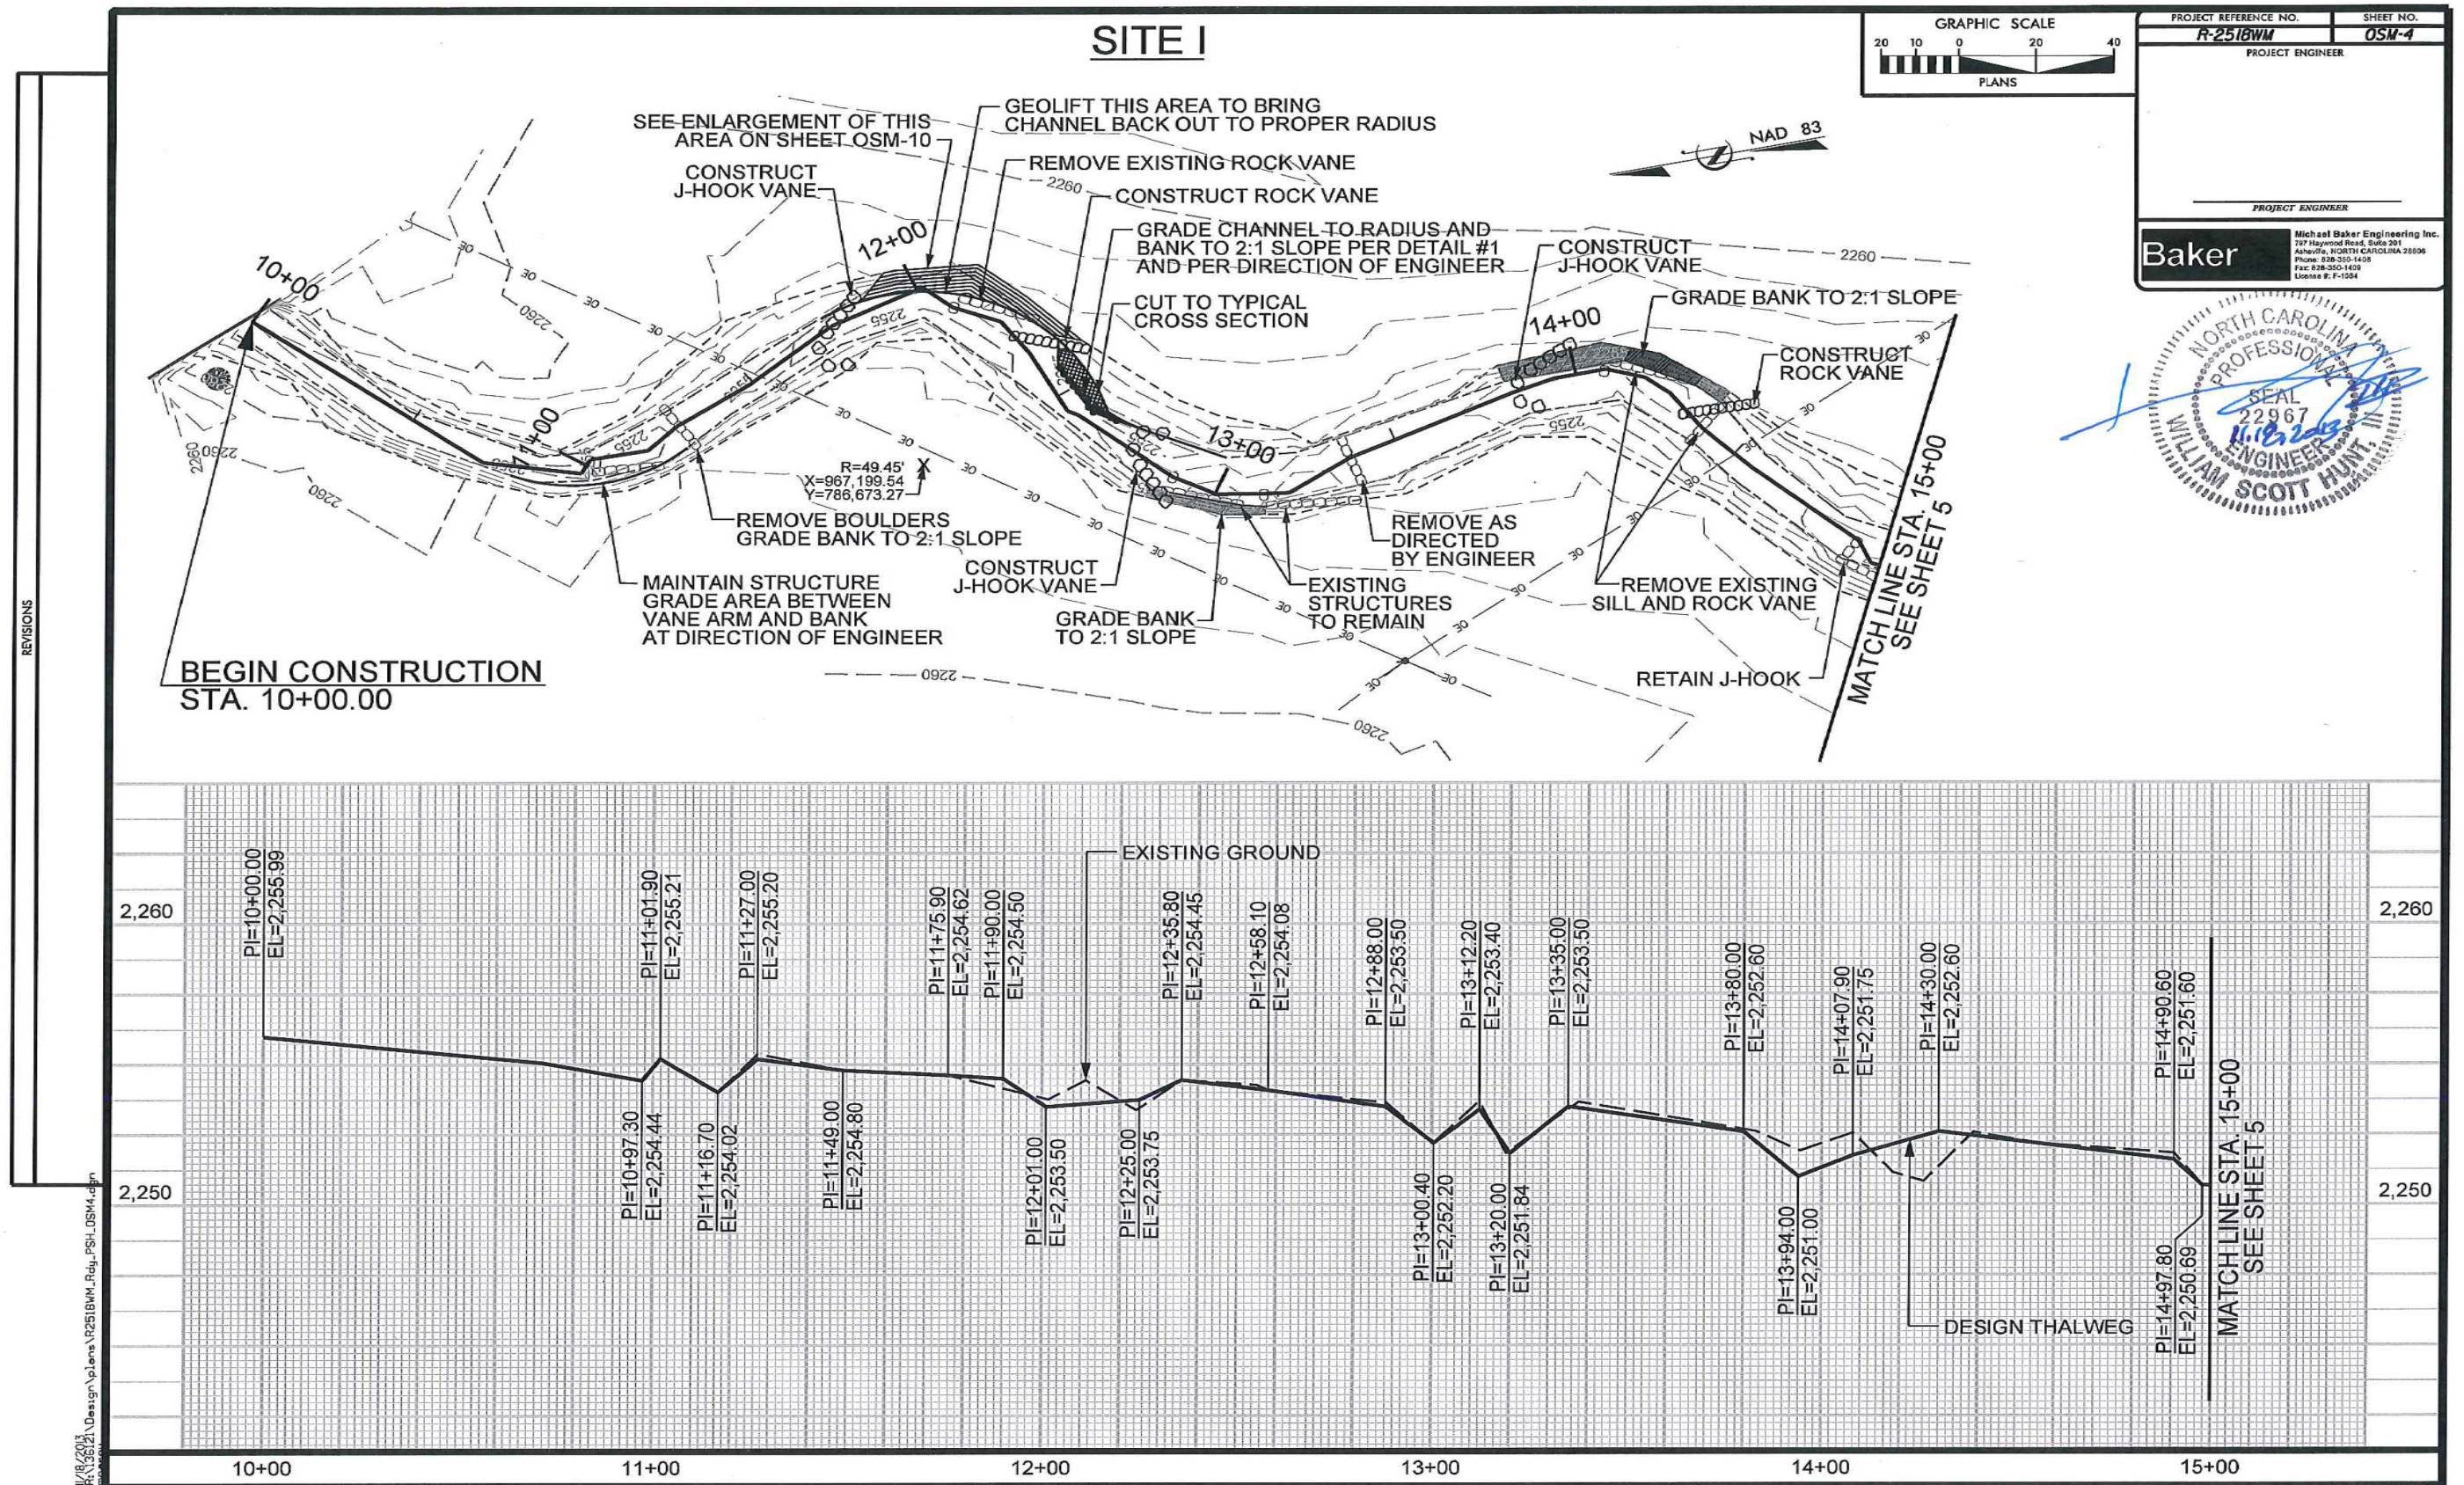
Figure 5. Site I Repair Plans

Stream repairs completed in June 2014 at Site I included constructing j-hooks, geolifts, rock vanes, boulder toe, grading work and removing some structures to stabilize the stream (see repair plans on pages 9 & 10). Cross Sections 3, 4, and 5 had to be reset due to the stream repairs, therefore, these cross sections were not overlaid with the previous year's data. (See Appendix A).

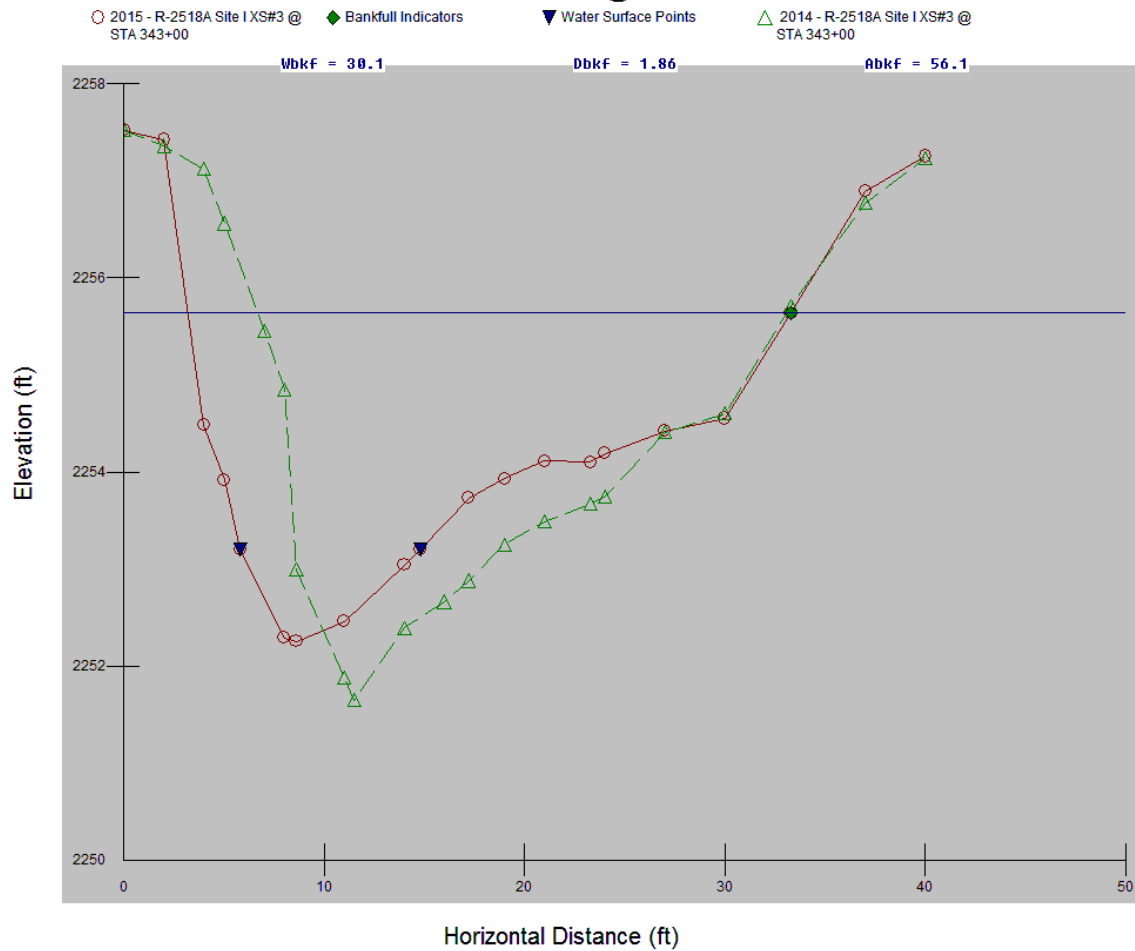
R-2518A Site I XS#3 @ STA 343+00

Based on the overall conclusions of monitoring at the Middle Fork Creek Site I, it has met the required monitoring protocols for the sixth formal year of monitoring on the stream, except for, a bank failure along the left bank at longitudinal profile Station 343+00 (Cross Section #3, Repair Plans Sta. 14+20). Further remedial action will be needed. Stream repairs completed in June 2014 at Site I included constructing j-hooks, geolifts, rock vanes, boulder toe, grading work and removing some structures to stabilize the stream (see repair plans on pages 7 & 8). It has met the fourth formal year of monitoring on the planted vegetation. A supplemental planting took place in March 2015 after the stream repairs and herbicide applications were completed.

It was noted during the 2015 monitoring that the left bank at longitudinal profile Sta. 343+00 (Cross Section #3) has eroded as depicted in the graph for Cross Section #3. During the 2014 monitoring, it was noted that there was an undercut bank between two J-hooks at longitudinal profile Sta. 441+00 and some boulder toe protection had dropped from the bank into the stream at Sta. 550+00. Live staking was completed in March 2015 to help stabilize these areas. These areas remain the same with little to no change. NCDOT will investigate the unstable bank at Cross Section #3 to see what remedial action is needed. Pebble counts were not required per the permit conditions and therefore were not completed. Four bankfull events were documented by a surface water gauge at Site I during the 2013 and 2014 monitoring years.

Site I: Cross-Section #3 (Pool) Abbreviated Morphological Summary						
	2010	2011	2012	2013	2014	2015
Bankfull Cross Sectional Area (ft ²)	60.29	65.99	64.06	56.03	56.73	56.09
Maximum Bankfull Depth (ft.)	4.35	4.7	4.47	4.22	4.06	3.39
Bankfull Mean Depth (ft.)	2.67	2.71	2.91	2.51	2.12	1.86
Bankfull Width (ft.)	22.59	24.38	22.03	22.36	26.77	30.09

NCDOT will investigate the unstable bank at Cross Section #3 to see what remedial action is needed and will continue monitoring the Middle Fork Creek Site I Mitigation Site in 2016.

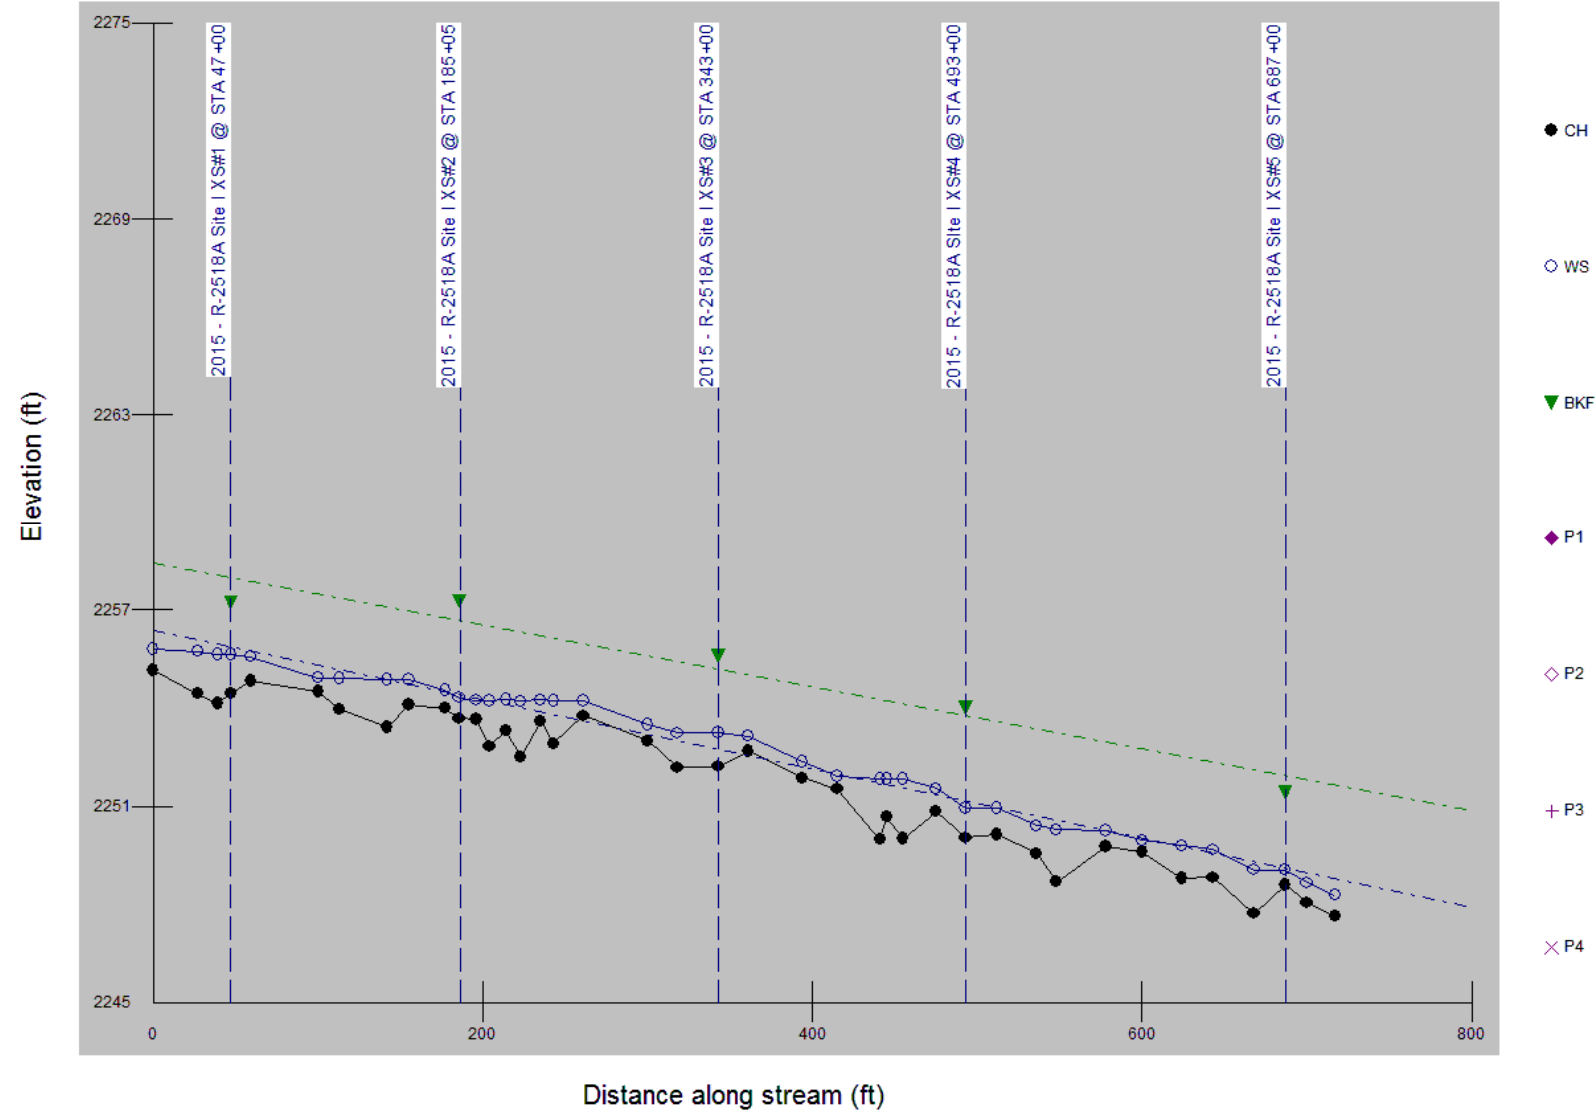
2015 - R-2518A Site I Profile

Based on comparisons of the As-Built to the monitoring data, all of the cross sections appear stable with little or no active bank erosion, except for, Cross Section #3. Graphs of the cross sections are presented in Appendix A. Future survey data will vary depending on actual location of rod placement and alignment; however, this information should remain similar in appearance. The longitudinal profile showed that the channel bed was stable for the 2015 monitoring evaluation.
